# FULL RESERVE STUDY

## Western Oaks Property Owner's Association, Inc.

Austin, Texas  
January 8, 2015

**Reference:** 141976

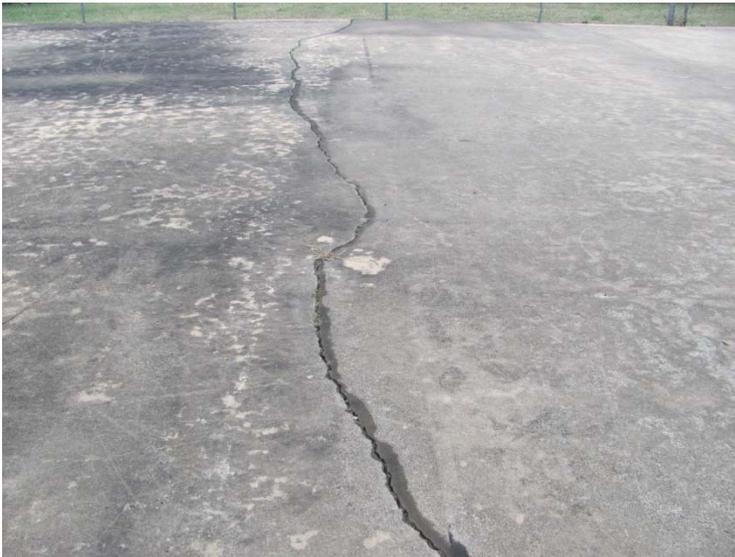
**Surface** - The basketball court playing surface is original and in fair to poor overall condition. We note cracks as shown on Page 5.2 of *Photographs*. Concrete playing surfaces have a useful life of 40- to 45-years. In consideration of the observed

Basketball court concrete crack

condition and to maintain a safe playing surface, we recommend the Association anticipate replacement by 2021. We note this information on Line Item 4.082 of *Reserve Expenditures*. We recommend replacement of the basketball standards from the operating budget on an as needed basis.

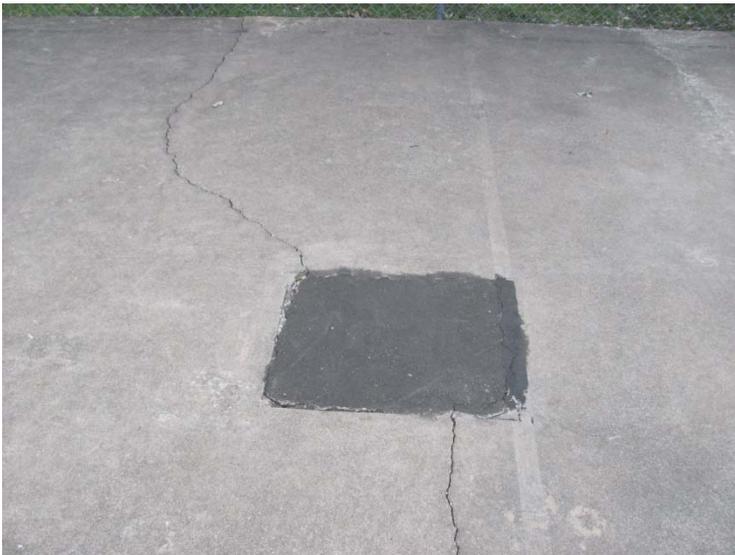
Basketball court crack and patch

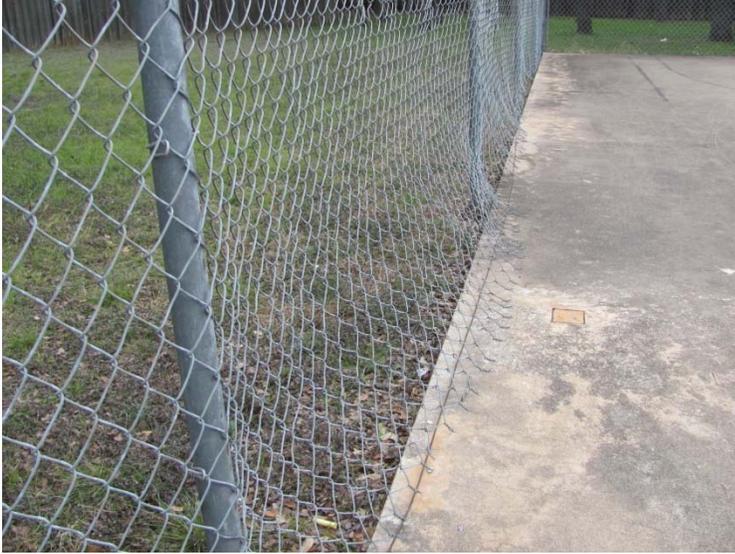
**Fence** - Approximately 300 linear feet of metal chain link fence enclose the basketball court. The chain link fence is in fair condition at an unknown age. We note fence curl as shown on Page 5.3 of *Photographs*. Chain link fences of this type have a useful life of up to 25 years. We recommend the Association anticipate replacement of the fence by 2021, concurrent with concrete surface replacement. We depict this information on Line Item 4.081 of *Reserve Expenditures*.

Chain link fence curl at basketball court

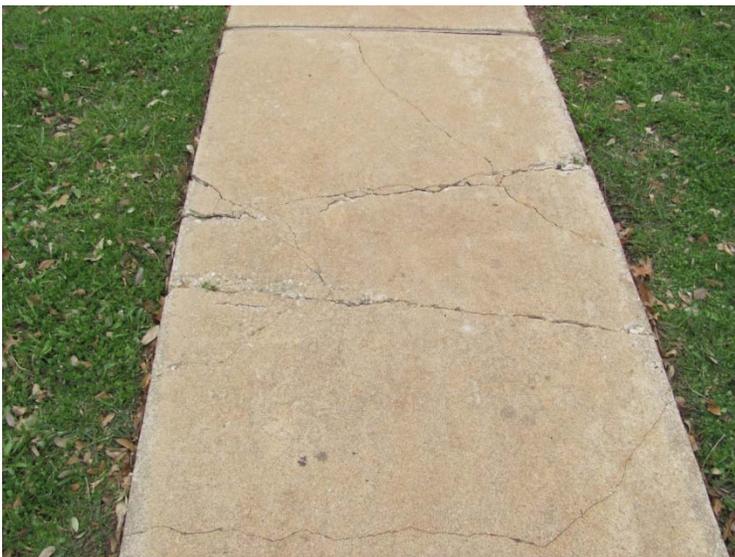
Sidewalk cracks

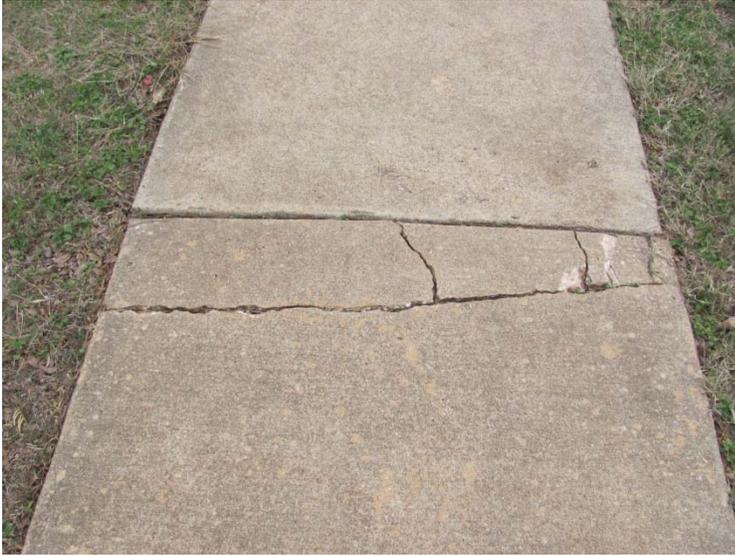
Sidewalk cracks

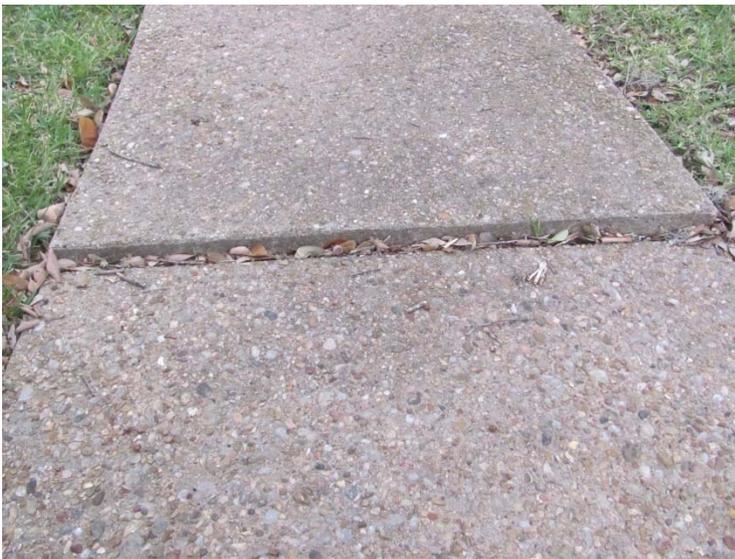
Sidewalk settlement

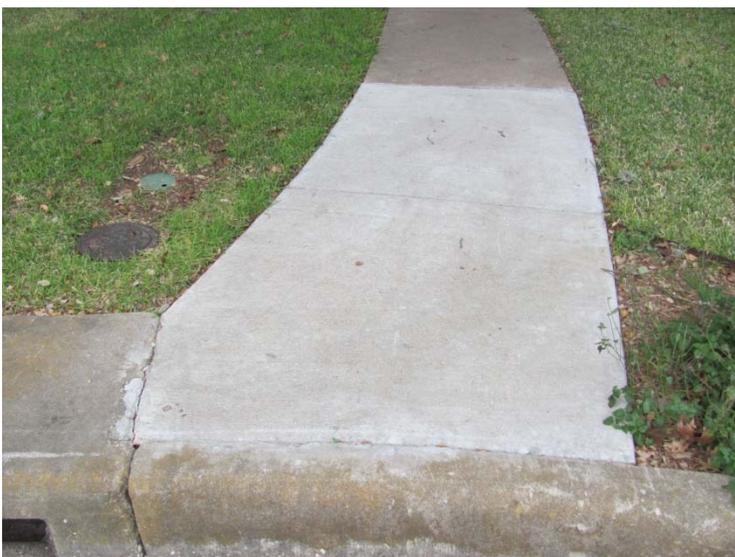
Sidewalk partial replacements

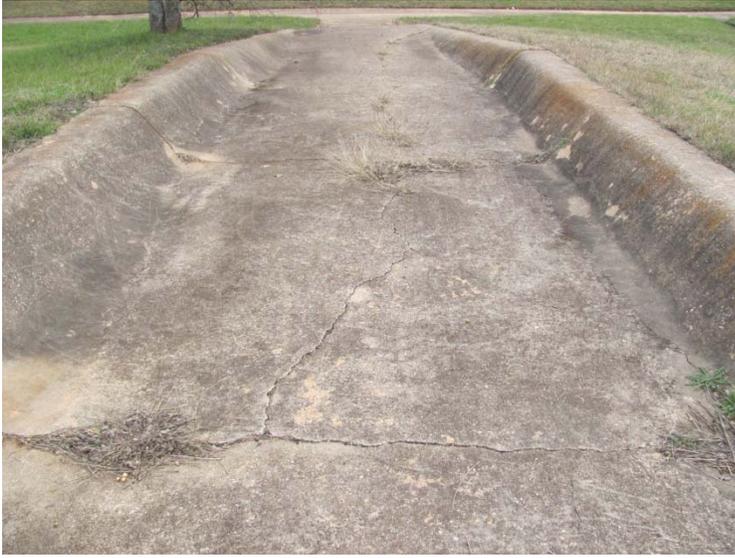
Concrete drainage swale

*Note: Cracks*

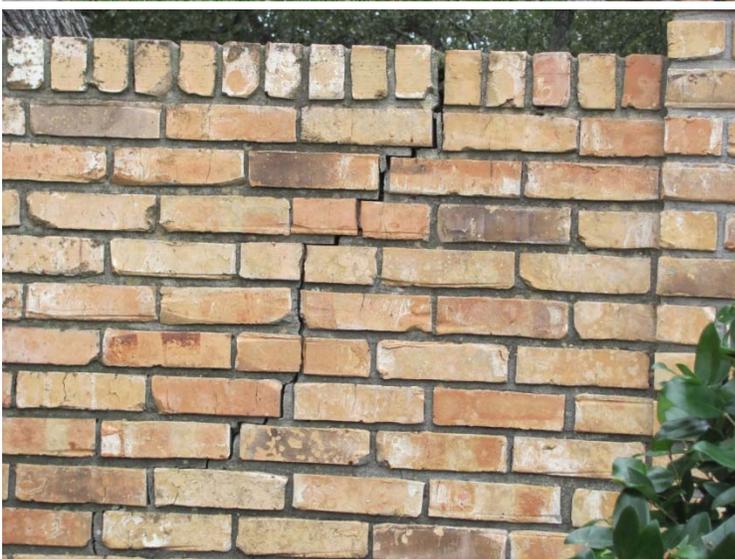
The primary cause of *efflorescence*, *cracks* and *face spall* is water infiltration, therefore prevention of water infiltration is the principal concern for the maintenance of masonry applications. Water infiltration is most likely to occur at the topsides of the walls or columns. Therefore, we recommend the Association consider installation of coping at the topsides of the walls and columns to inhibit further infiltration of water inside the wall and column cavities. This will maximize the useful life of these masonry applications.

Masonry crack at entrance monument

*Repointing* is a process of raking and cutting out defective mortar to a depth of not less than  $\frac{1}{2}$  inch nor more than  $\frac{3}{4}$  inch and replacing it with new mortar. We advise a complete inspection of the perimeter walls, and partial repointing with related masonry repairs every 8- to 12-years to forestall deterioration. We suggest that the Association budget for repointing of up to three percent (3%) and partial replacement of up to one percent (1%) of the masonry in 2016 and every 10 years thereafter. We depict this information on Line Item 4.640 of ***Reserve Expenditures***.

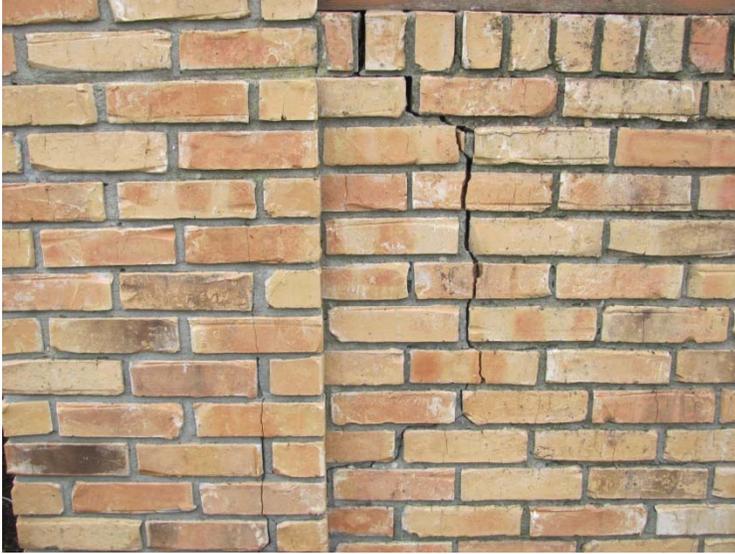
Masonry crack at entrance monument

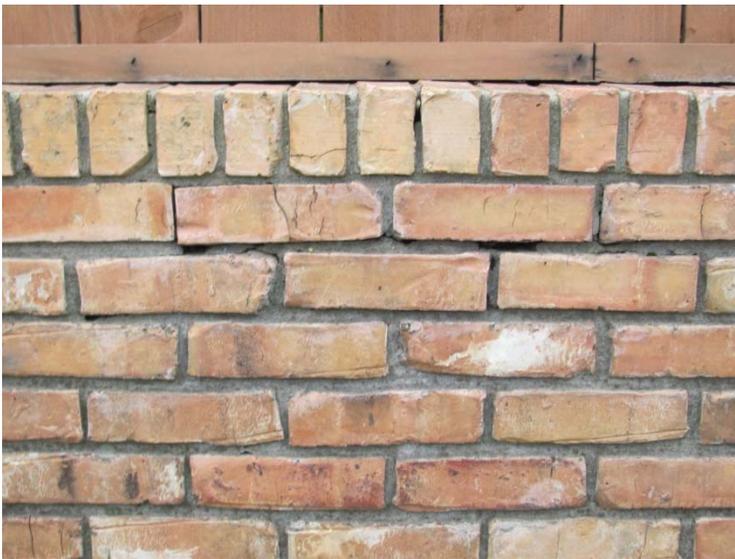
Masonry mortar deterioration

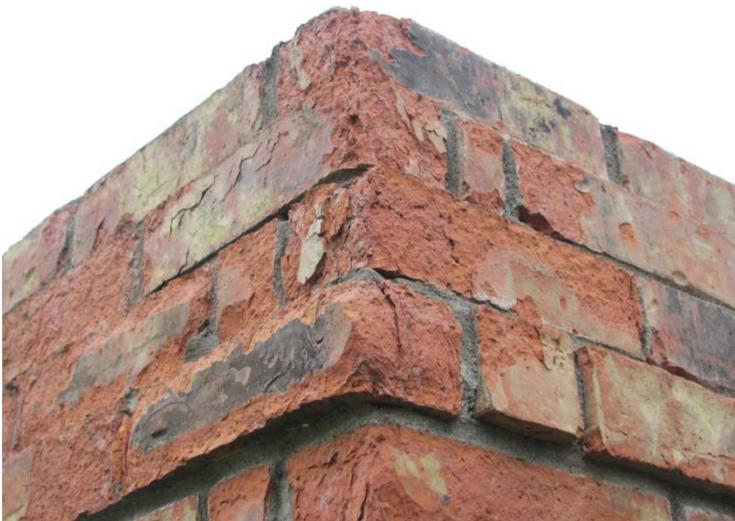
Masonry pillar delamination at pool

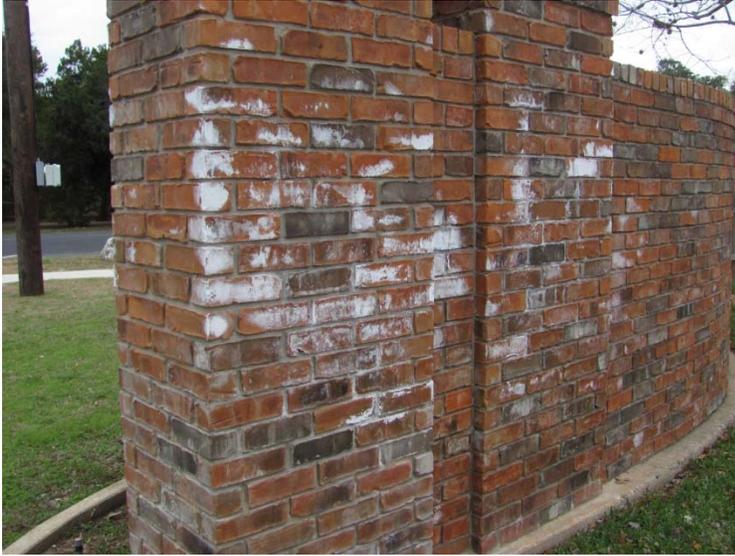
Masonry efflorescence

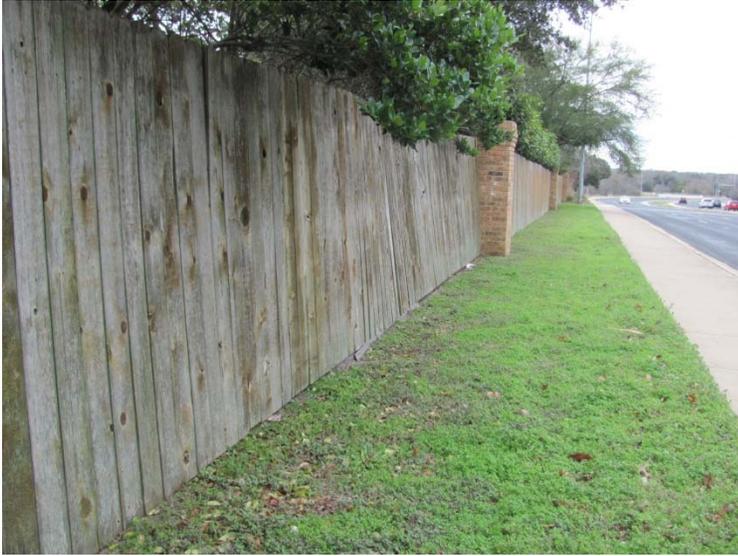
**Perimeter Walls, Wood Fences-** Approximately 800 linear feet of stockade wood fences are found at the Robert Dixon Drive entrance. The fences are in good to fair overall condition at an unknown age. We note leaning sections, wood rot and partial replacements as shown on Page 5.8 of *Photographs*. Wood fences of this type have useful lives of 15- to 20-years. The Association should anticipate periodic partial replacements due to the non-uniform nature of wood deterioration. Along with these partial replacements, the Association should apply periodic paint applications as needed and fund these activities through the operating budget. We suggest the Association plan for replacement by 2021 and again by 2041. We depict this information on Line Item 4.642 of *Reserve Expenditures*.

Fence leaning sections

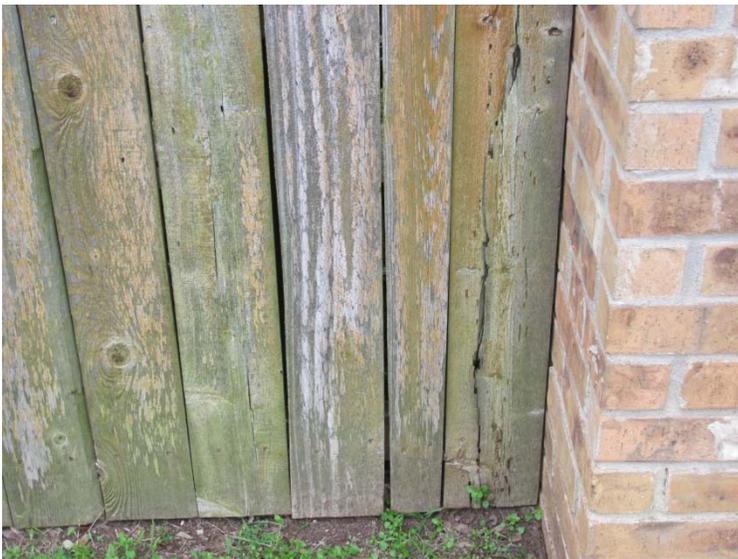
Fence wood rot

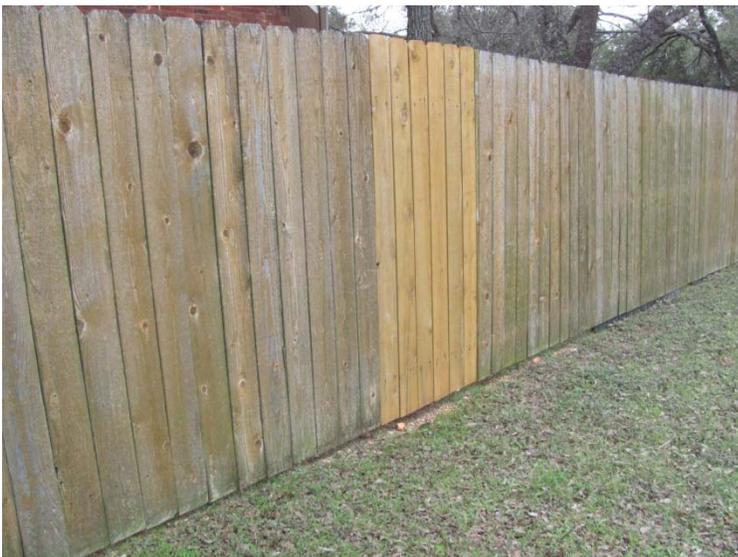
Fence partial replacements

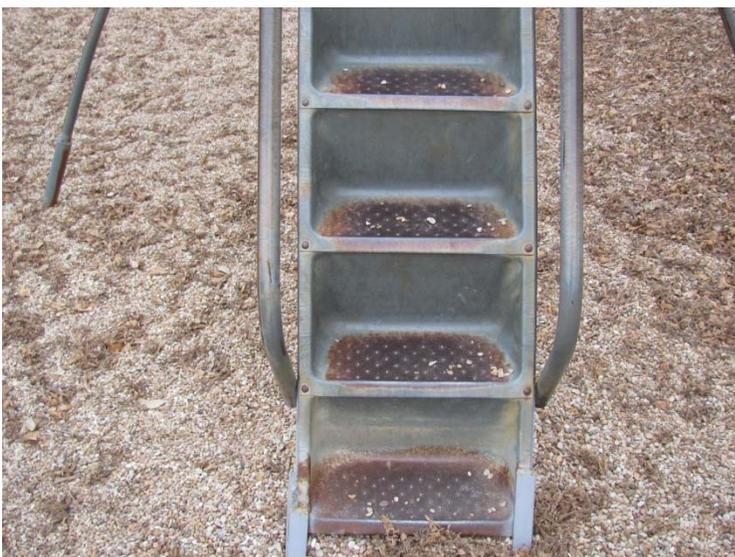
We note rust at the original playground equipment as shown on Pages 5.9 and 5.10 of *Photographs*. Safety is the major purpose for maintaining playground equipment. We recommend an annual inspection of the playground equipment to identify and repair as normal maintenance loose connections and fasteners or damaged elements. We suggest the Association learn more about the specific requirements of playground equipment at [PlaygroundSafety.org](http://PlaygroundSafety.org). We recommend the use of a specialist for the design or replacement of the playground equipment environment. Playground equipment of this type has a useful life of 15- to 20- years. Management informs us the Association budgeted an allowance of \$13,000 in 2015 for partial replacement of the original playground equipment. We estimate that the Association should budget an additional allowance of \$18,000 plus inflation in 2016 to remove and replace the remaining original playground equipment, including the wood playset structure. We recommend the Association budget for subsequent replacement of all of the playground equipment by 2032. The exact cost of the near term replacements may vary based on the age of the current playground equipment and the selected new replacement equipment. However, we judge the amounts shown on Line Items 4.700 and 4.701 *Reserve Expenditures* sufficient to budget appropriate reserves.

Playground equipment rust

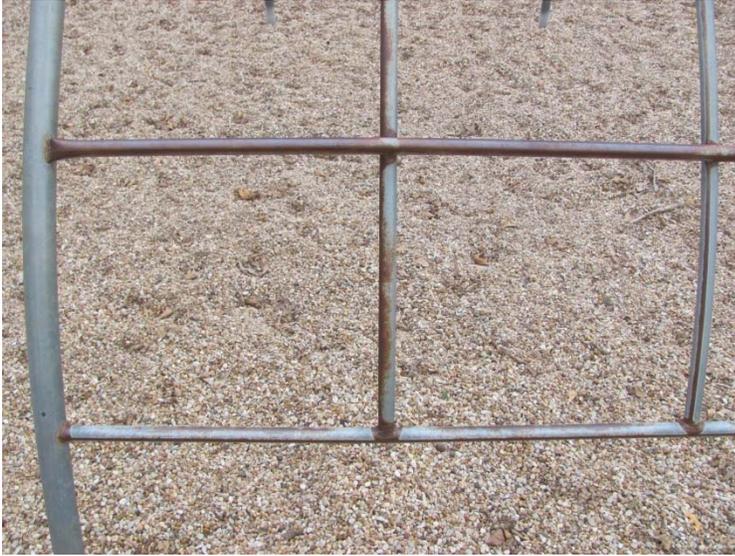
Playground equipment rust

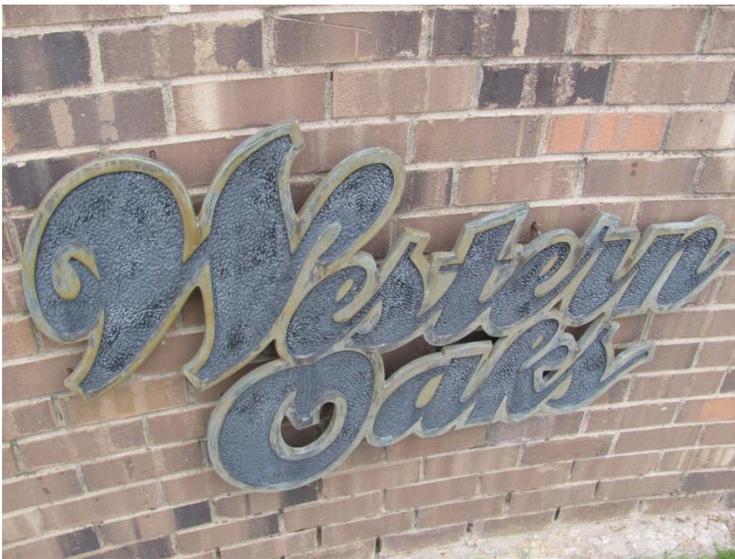
**Signage** - The Association maintains 12 entrance monuments with metal signs and landscape light fixtures at the various entrances to the community. The signs are original and in fair condition. We note color fade of the metal signs as shown on Page 5.10 of *Photographs*. The functional useful life of the signs is 15- to 20-years. The community signs contribute to the overall aesthetic appearance to owners and potential buyers. Replacement of community signs is often predicated upon the desire to "update" the perceived identity of the community rather than for utilitarian concerns. Therefore, the specific times for the replacement of the signs is discretionary. We recommend the Association plan to replace the signs by 2019 and again by 2039. We include replacement of the light fixtures in our cost. We note this information on Line Item 4.810 of *Reserve Expenditures*. We include repairs to the masonry at the monuments with the perimeter walls and columns

Entrance monument signage

*Note: Color fade*

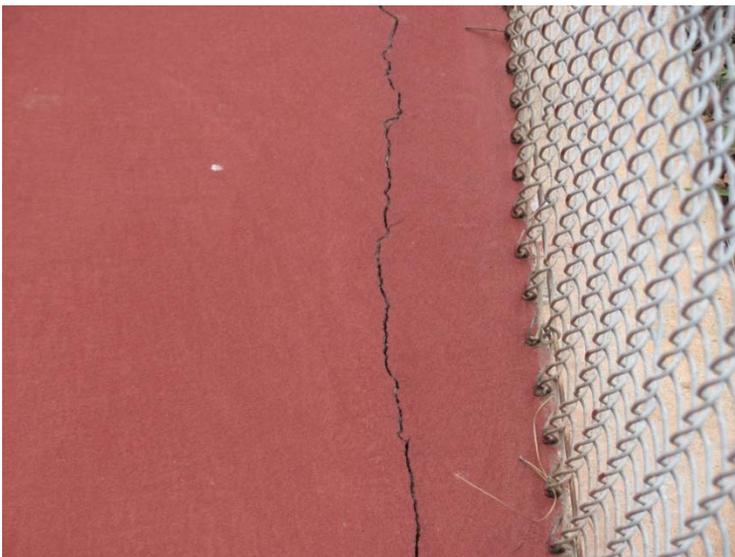
***Surface*** - As previously stated, the Bent Oak Circle concrete playing surface is in good condition at an age of one year. We note isolated edge cracks as shown on Page 5.11 of ***Photographs***. The Woodcreek Road and Wheeler Branch Trail asphalt surfaces are in fair overall condition. We note multiple cracks at both locations as shown on Pages 5.11 and 5.12 of ***Photographs***. Concrete tennis courts have a useful life of 40- to 45-years. Therefore, we do not anticipate complete replacement in the next 30 years with proper maintenance and color coat applications. The asphalt tennis courts have a shorter useful life of up to 25 years. In consideration of the observed condition and to maintain a safe playing surface at the asphalt pavement courts, we recommend the Association anticipate replacement by 2020 and again by 2045. We note this information on Line Item 4.860 of ***Reserve Expenditures***. We recommend replacement of the tennis standards from the operating budget on an as needed basis.

Isolated edge crack at Bent Oak Circle court

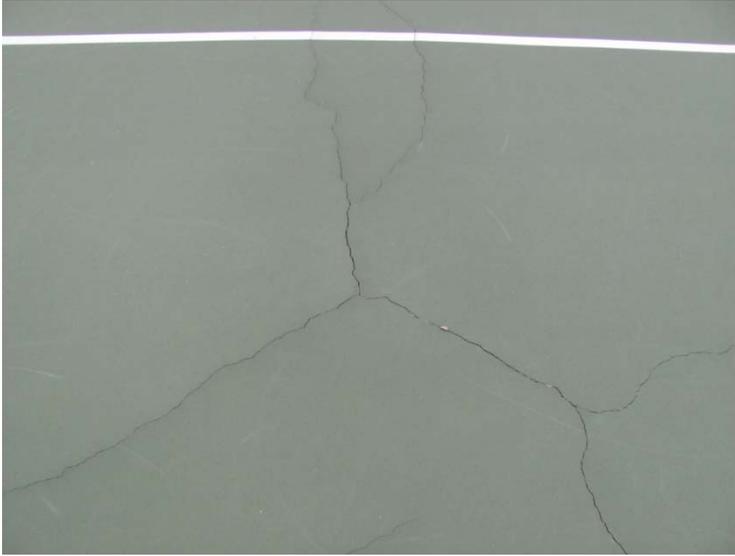
Tennis court cracks at Wheeler Branch Trail

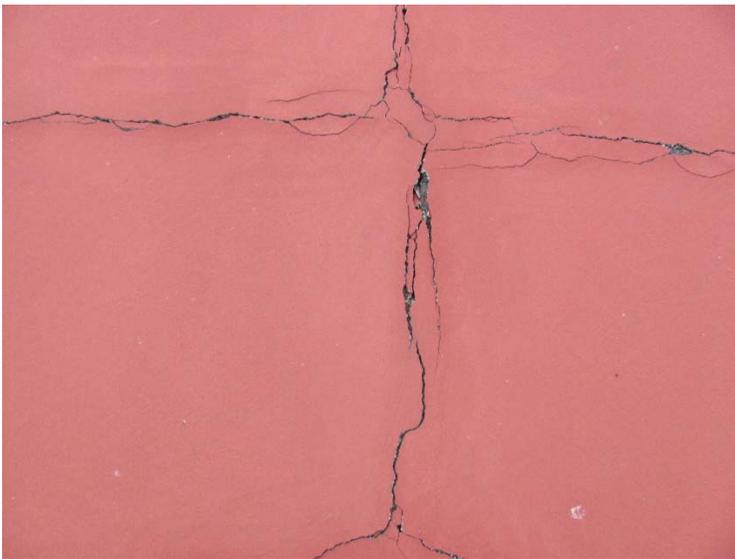
Tennis court cracks at Woodcreek Road

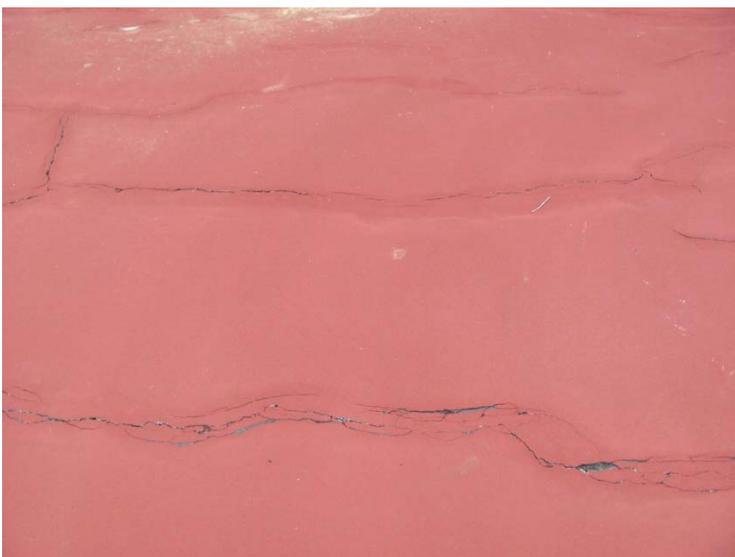
Tennis court cracks Woodcreek Road

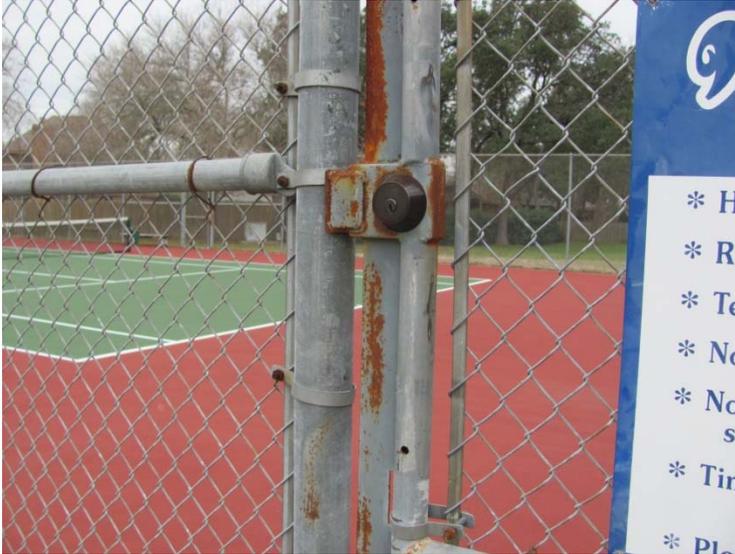
Gate rust at Bent Oak Circle tennis court

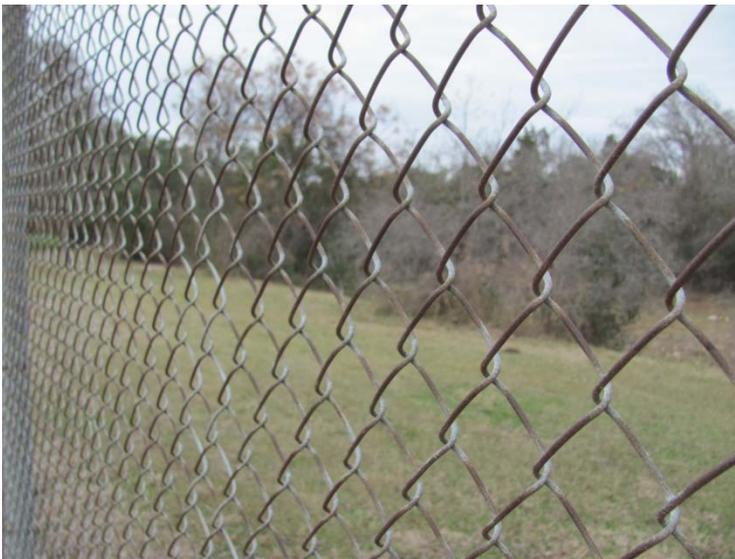
Tennis court chain link fence rust

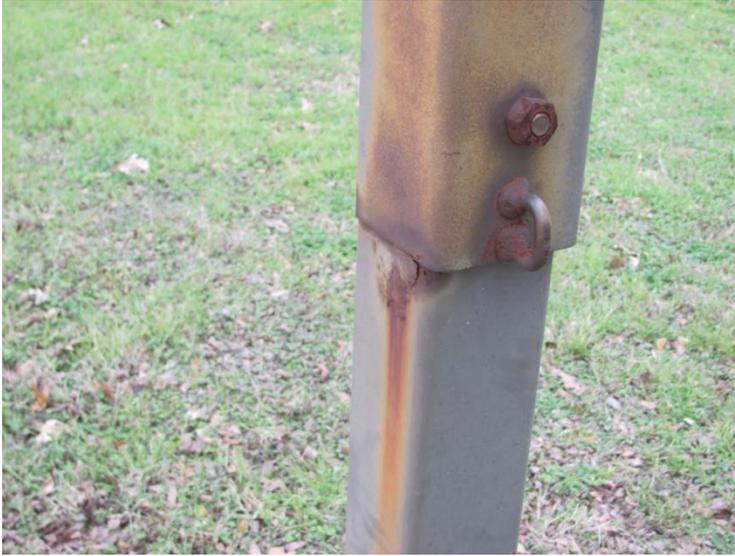
Light pole rust

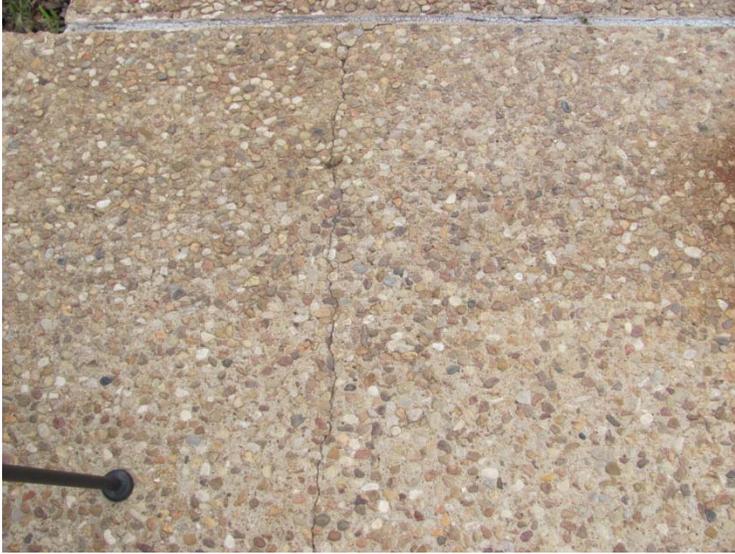
**Concrete Deck** - A textured concrete deck surrounds the pool and comprises approximately 3,500 square feet. The deck is original and in good to fair condition. We note cracks and joint sealant deterioration as shown on Page 5.15 of *Photographs*. The useful life of a concrete pool deck is up to 60 years. However, we recommend the Association conduct inspections, partial replacements and repairs to the deck every 8- to 12-years.

Concrete deck crack

- Selective cut out and replacements of up to ten percent (10%) of concrete
- Crack repairs as needed
- Mortar joint repairs
- Caulk replacement

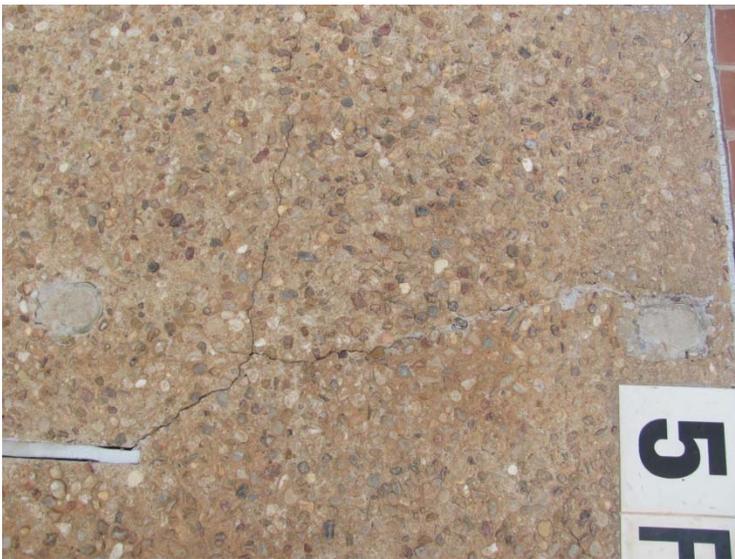
Concrete deck crack

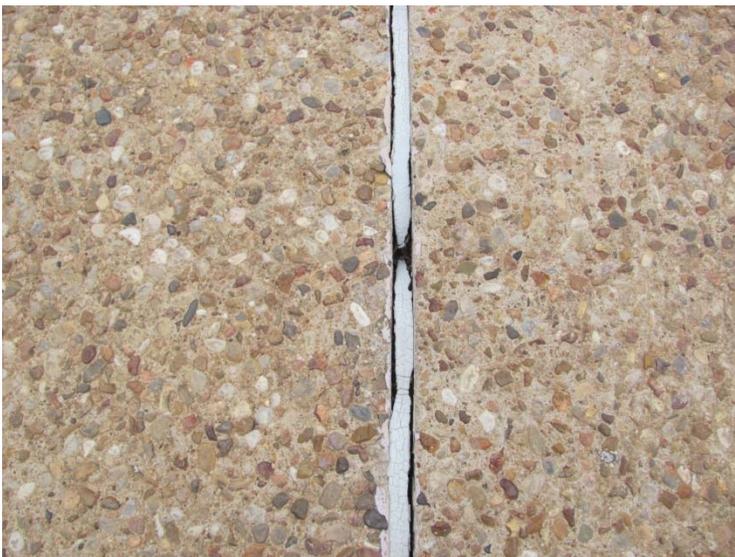
Sealant deterioration

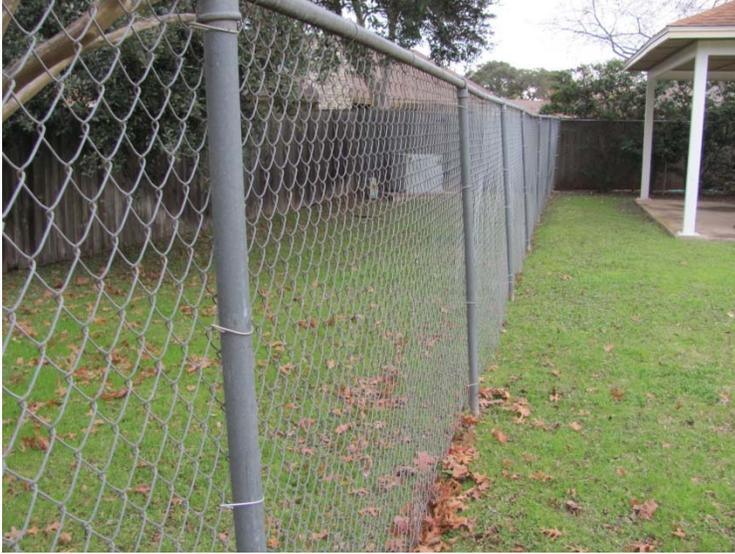
Leaning chain link sections

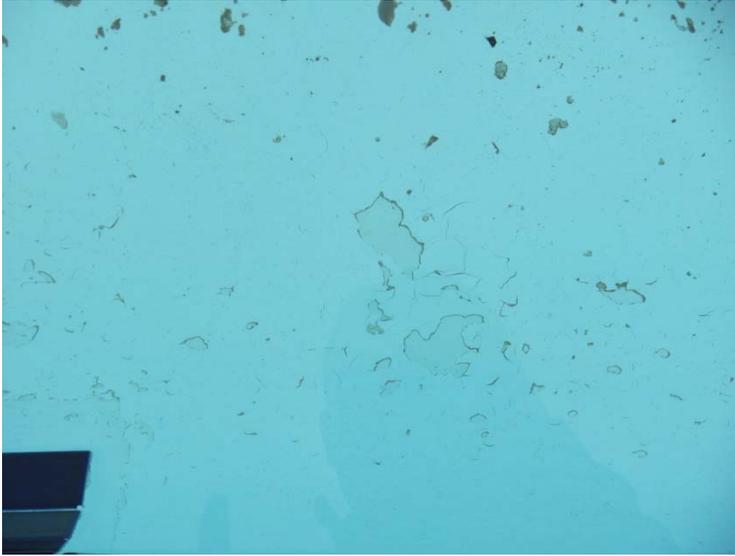
Pool finish deterioration

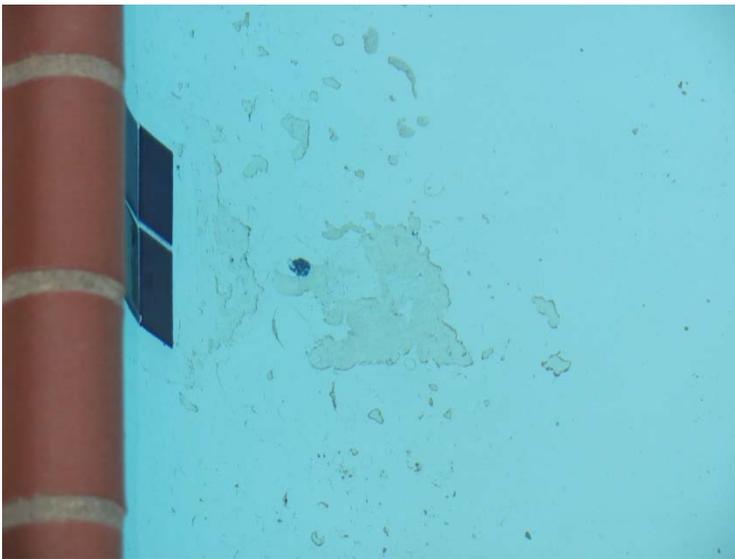
Pool finish deterioration

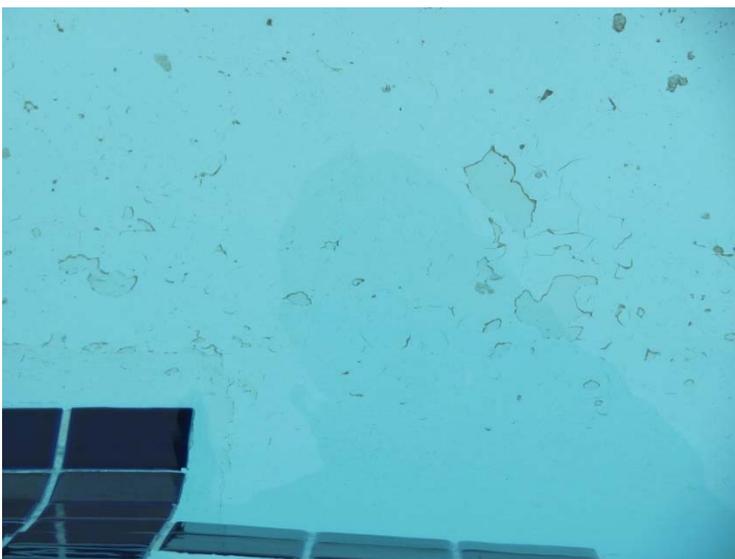
Pool finish deterioration

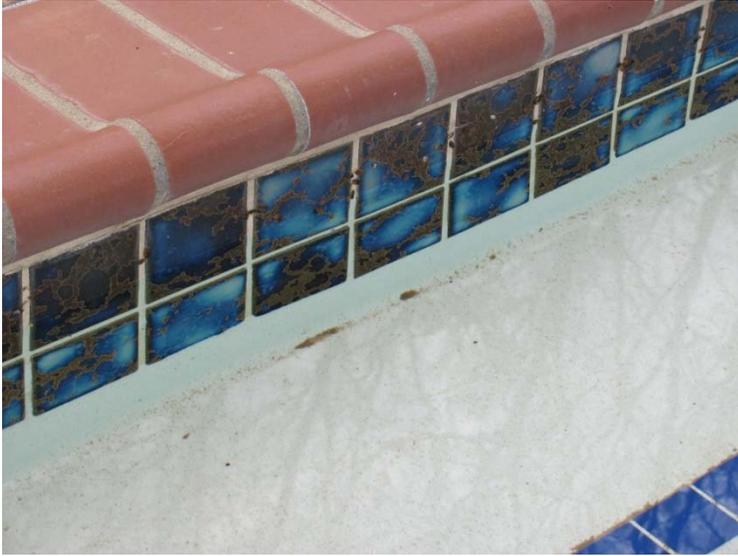
Pool tile discoloration

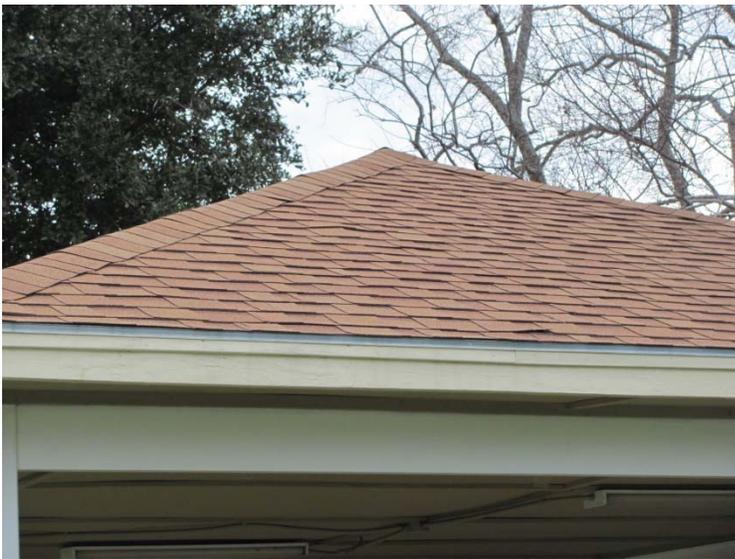
Asphalt shingle roof

*Note: Isolated shingle lift*

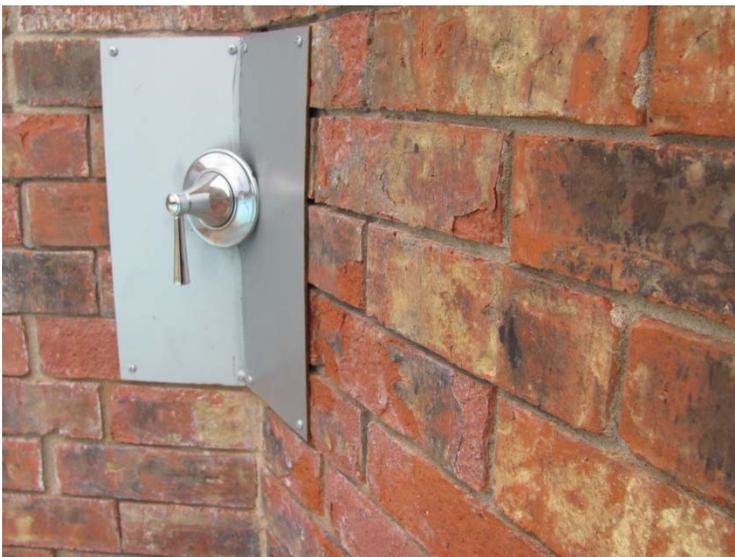
Masonry delamination at rest room building

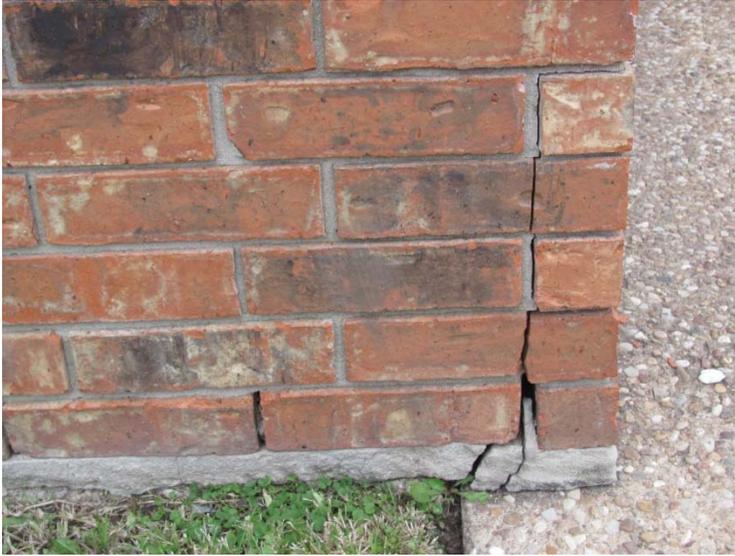
Masonry wall crack at rest room building

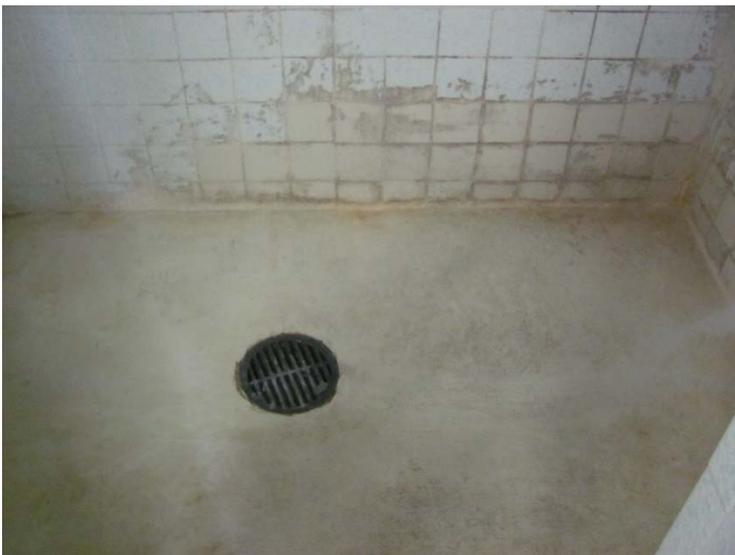
Shower tile deterioration

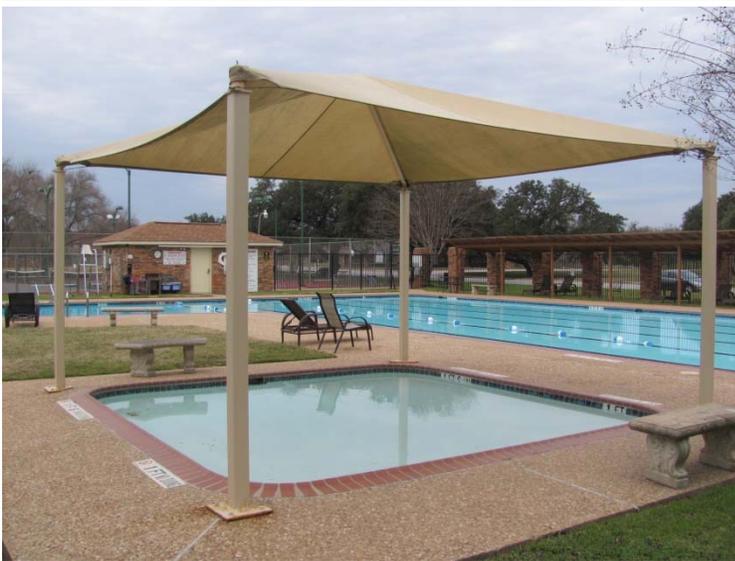
Shade structure

*Note: Discoloration of the canopy*

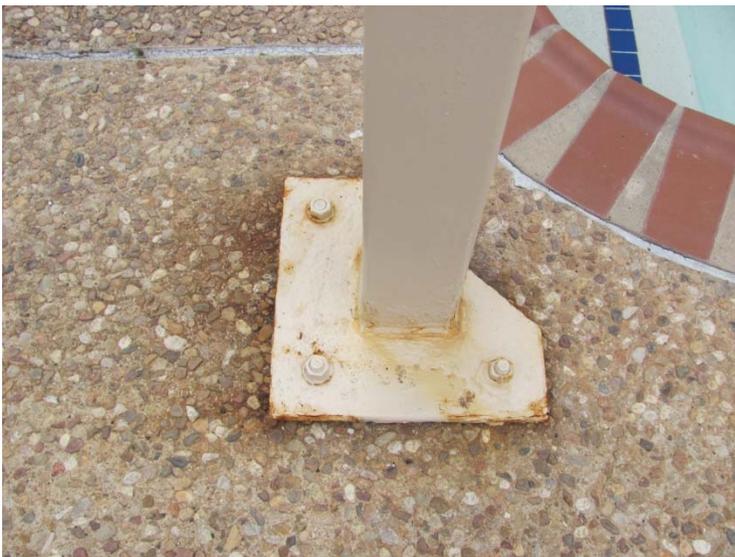
Rust at shade structure support column
